Nickel-Chromium-Molybdenum Superalloys: The Solution to Corrosion Problems in Wet Limestone FGD Air Pollution Control Systems

Lewis E. Shoemaker and James R. Crum
Special Metals Corporation, Huntington, WV USA

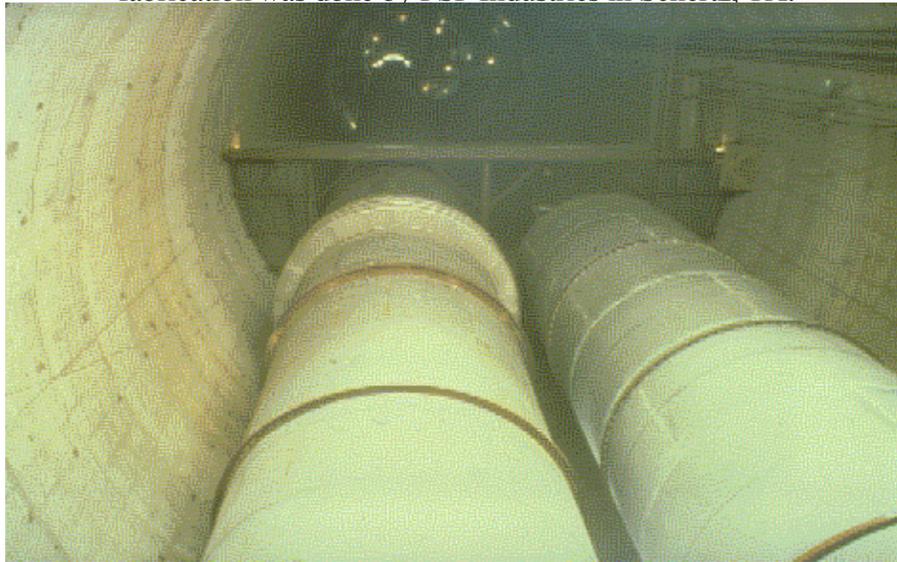
Figure 10

FGD chimney flues at the Bruce Mansfield Station of the Pennsylvania Power Company in Shippingport, PA. The flues are fabricated from $\frac{1}{4}$ " (6.4 mm) INCONEL alloy 625 plate. Alloy clad steel plate could have been a product option for these components. In the years following the construction of these flues in 1980, alloy clad steel plate has indeed become the product of choice for such fabrication.

Perhaps the most straight forward type of construction is to simply fabricate the vessel, duct or flue from alloy plate. Thus, the plate acts as both a structural member and a barrier against corrosion. Nickel alloy plates offer high strength along with excellent ductility so they are readily formed by conventional equipment and procedures. The use of alloy plate is particularly effective for components exposed to severely corrosive conditions or abrasion. Solid plate is commonly used for scrubber vessel and duct walls (Figure 9), floors, turning vanes, chimney breeching, chimney flues (Figure 10) and storm caps.

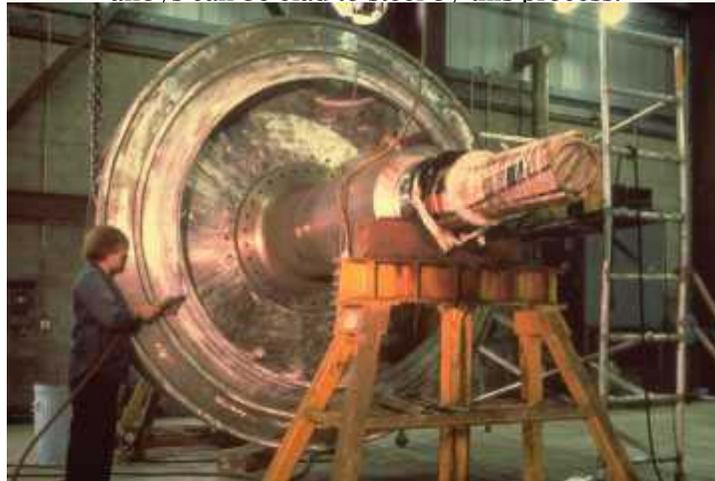
Figure 12

An induced draft fan fabricated from INCONEL alloy 625 plate. Fans are used to force the wet scrubbed gases through the scrubbing system and up the chimney when natural draft is insufficient. Because of its high tensile and fatigue strength along with its excellent corrosion-resistance, alloy 625 is the material of choice for such components.

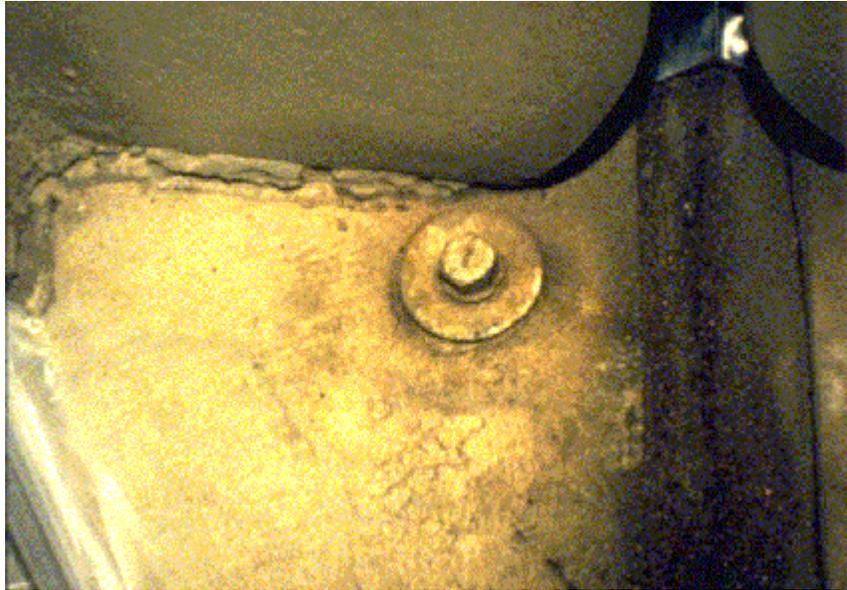
Figure 13

Severe corrosion of an alloy C-276 weldment and alloy C-276 plate in the by-pass duct at the Seminole Electric Cooperative Station in Palatka, FL. This is one of the few occurrences of rapid corrosion of alloy C-276 under FGD conditions.

Shortly after its commercial introduction, INCONEL alloy 686 was employed to solve a major corrosion problem at the Seminole Electric Cooperative Power station in Palatka, Florida, USA. The alloy C-276 lining in a by-pass duct was being rapidly attacked by a corrosive media that was condensing on the walls and standing on the floor. Alloy C-276 plate was corroding at the excessively high rate of 40 mpy. However, alloy C-276 weldments had been essentially corroded away due to the effects of elemental segregation (Figure 13). These welds were replaced by

To determine why the alloy C-276 lining was corroding at such a high rate, the condensate inside the duct was analyzed. It was found to contain 127,000 ppm chlorides, 2,900 ppm fluorides, and 180,200 ppm sulfates at a pH of 0.8 ! Thus, it is not surprising that alloy C-276 corroded under these conditions. What is most important, however, is that alloy 686 products, even segregated weldments, were able to resist this environment.
